Docket No. 217 – Development and Management Plan Inspection

Northeast Utilities Service Company Certificate of Environmental Compatibility and Public Need for the construction of a 345-kV electric transmission line and reconstruction of an existing 115-kV electric transmission line between Connecticut Light and Power Company's Plumtree Substation in Bethel, through the towns of Redding, Weston, and Wilton, and to the Norwalk Substation in Norwalk, Connecticut.

Date: December 1, 2005

Location: Norwalk Substation Expansion

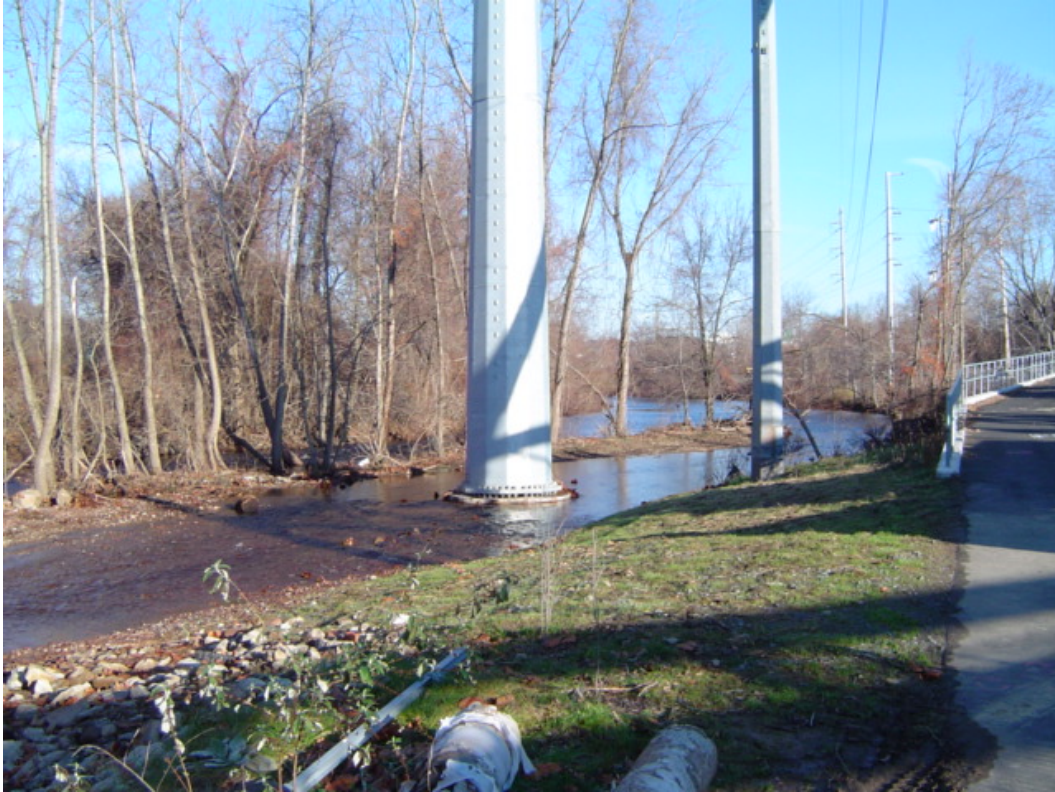
Norwalk Substation: View of the 345kV Turning Structure and the restored portion of the natural overflow channel. 12/01/05.

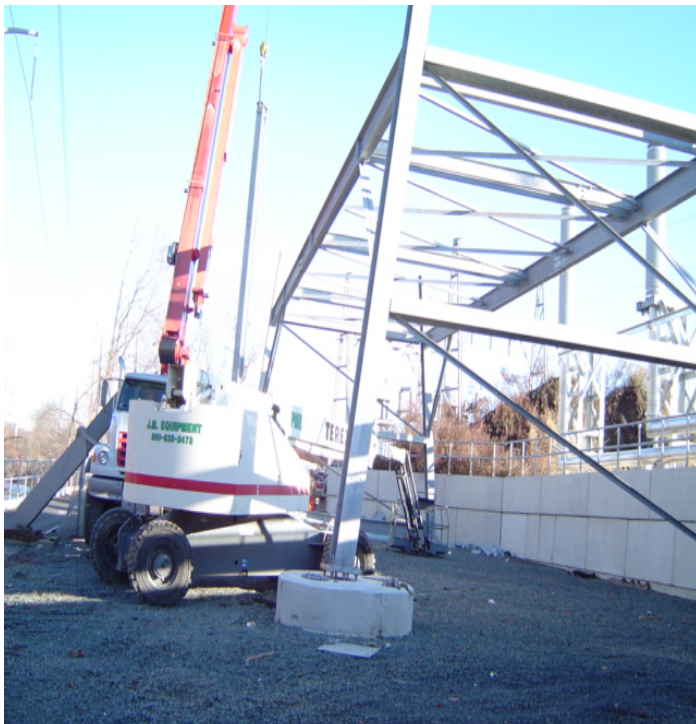
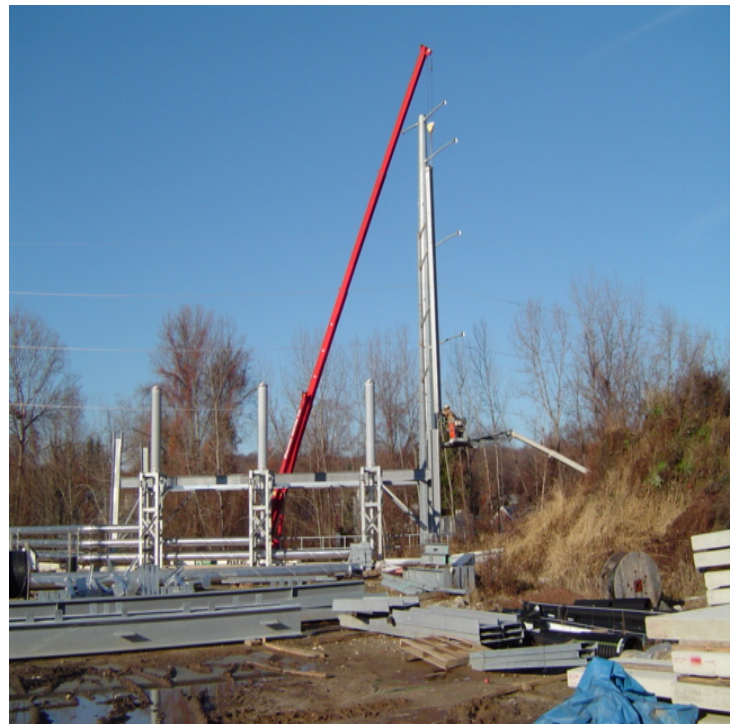
Views of the structures being installed in the northwest portion of the yard. 12/01/05.

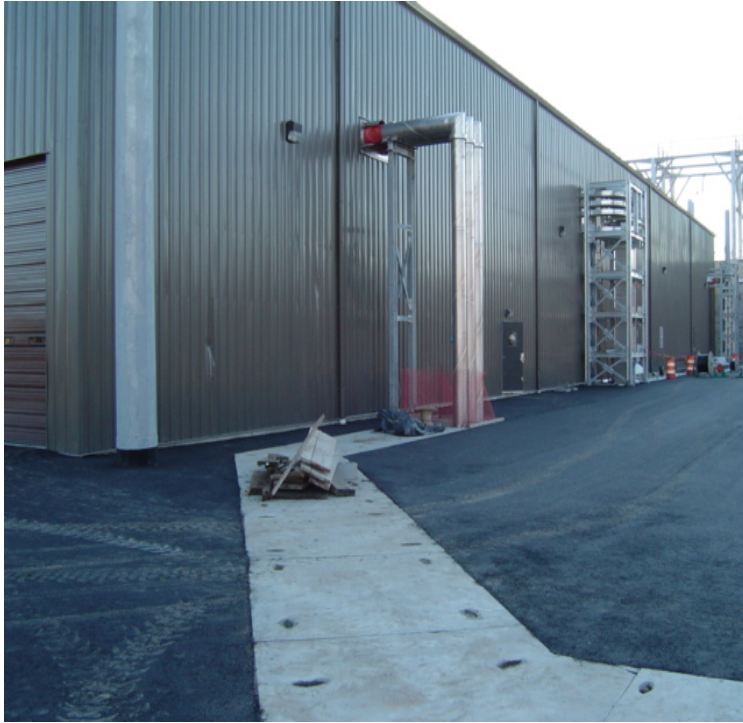
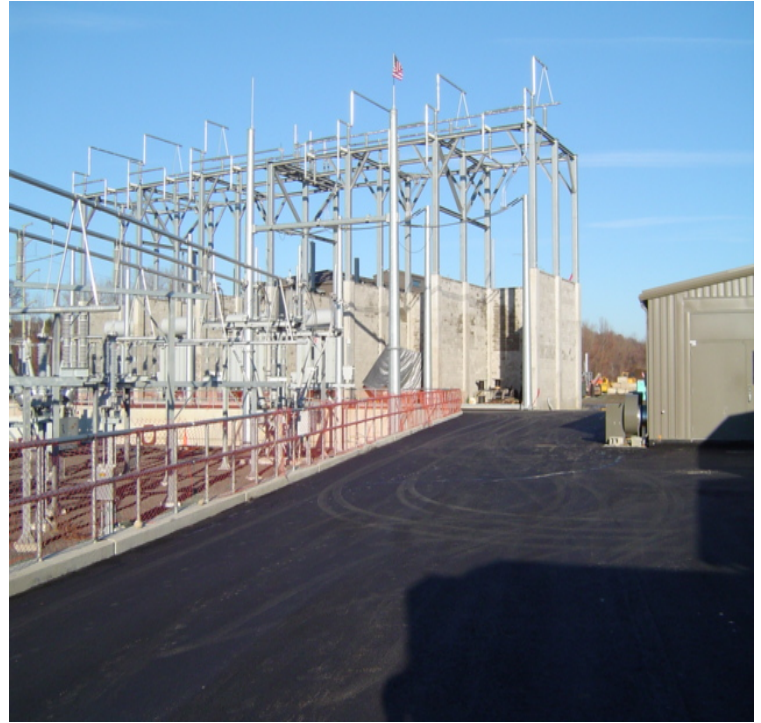
Paving has occurred over significant portions of the site. Photo on the left shows the area adjacent to the GIS building where excavation work is complete. Photo on the right shows the access road leading around the yard. 12/01/05.

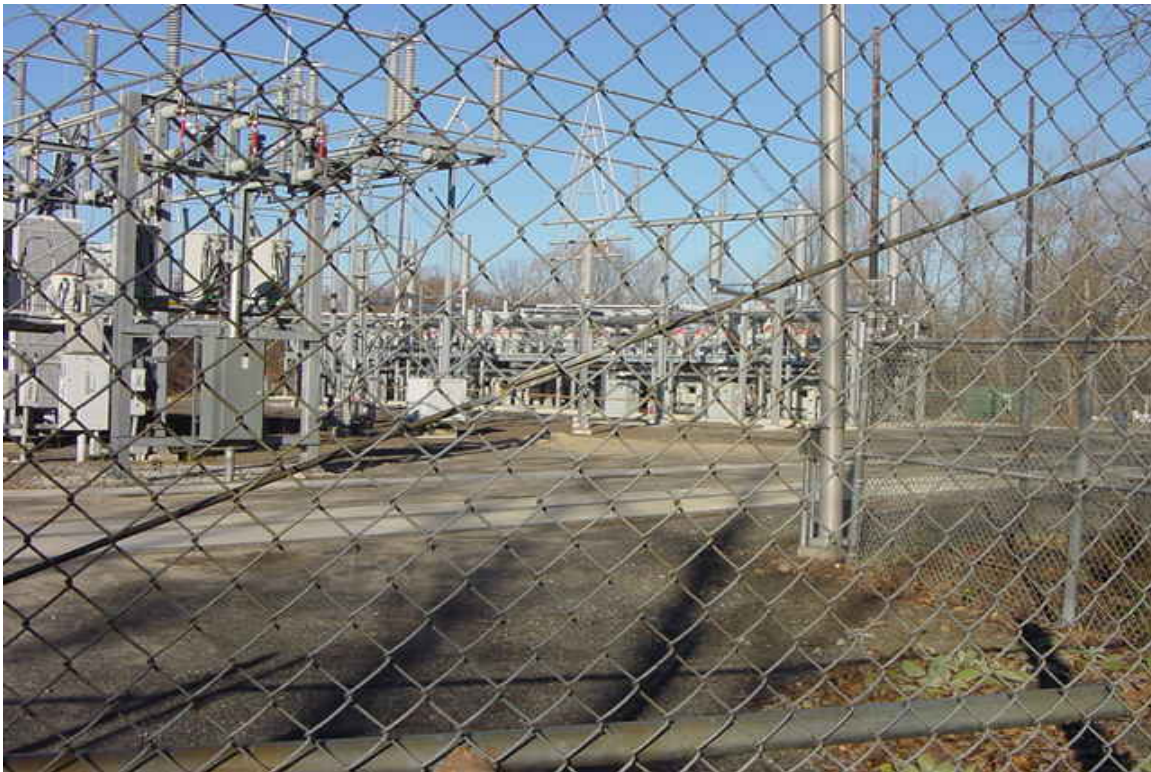
Plumtree Substation: Most substation related work here is complete. 12/01/05.
